STUDY OF BEHAVIOR OF GRILLAGES IN ELASTIC AND PLASTIC RANGES

FINAL REPORT

Contract No. N00024-67-C-5356
Project Serial No. S-F013 C3 01 Task 2050
SwRI Project No. 03-2101-01

for
Naval Ship Systems Command
Department of the Navy
Washington, D. C. 20360

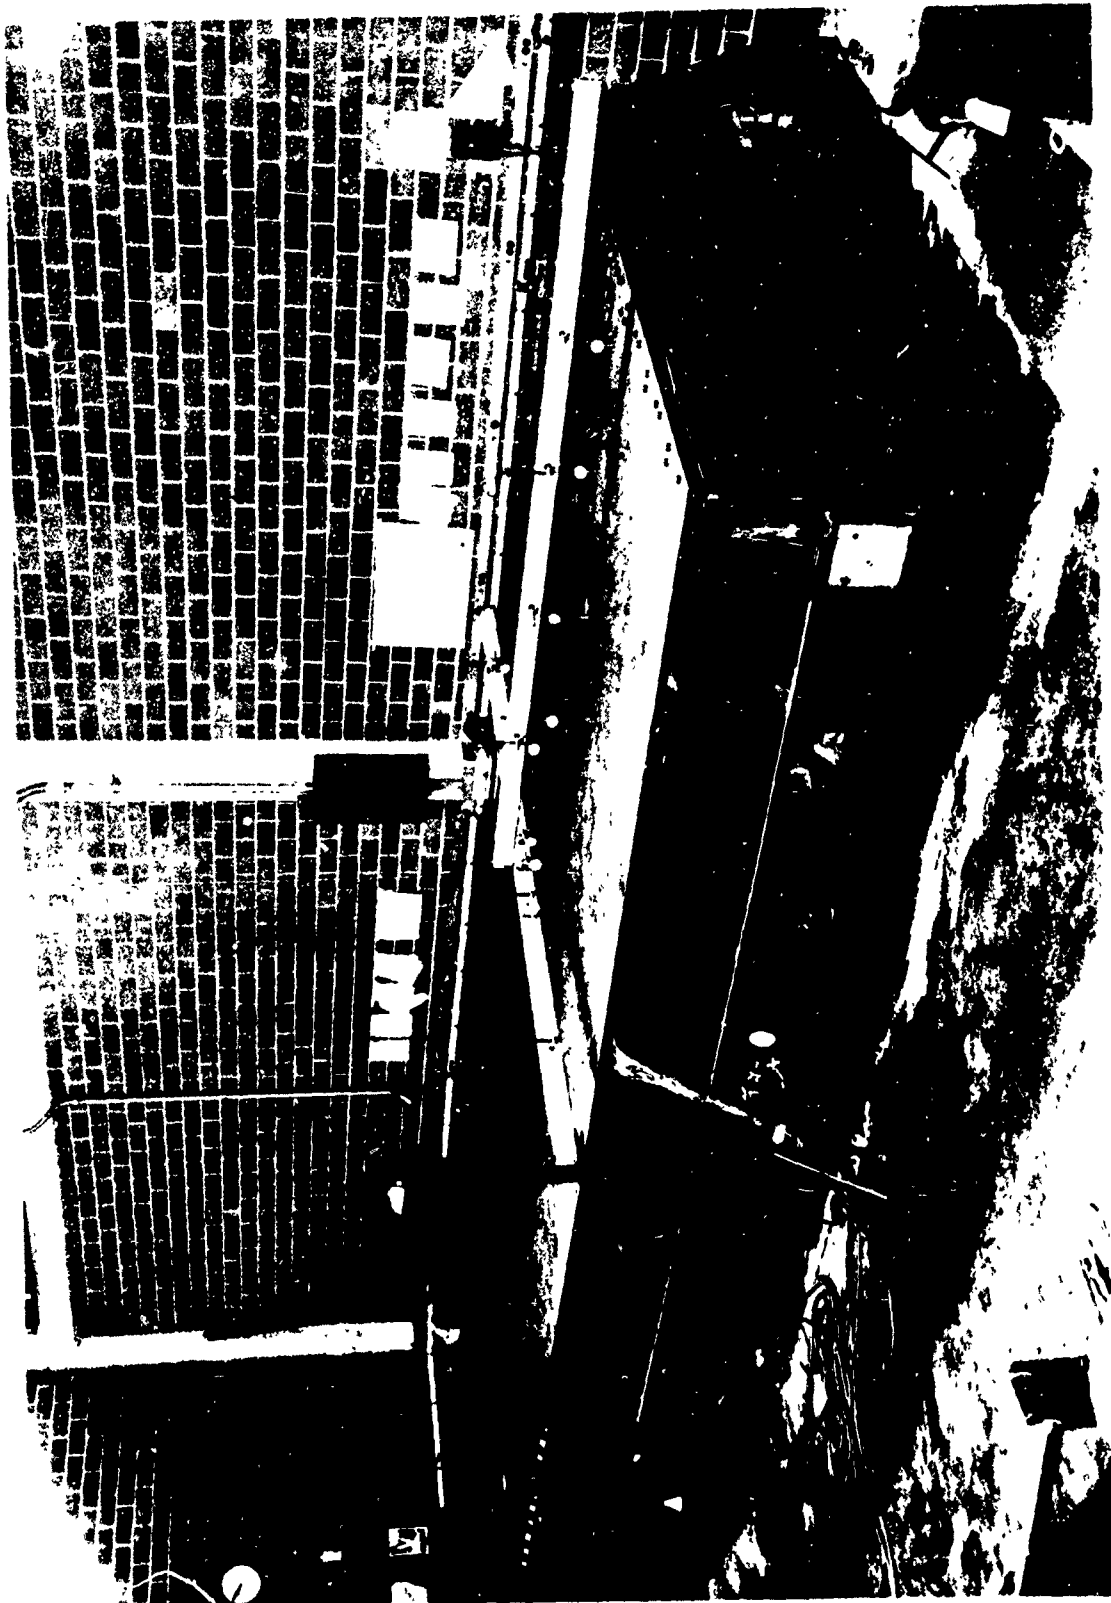
FIGURE 4. THE GRILLAGE SPECIMEN UNDERGOING TEST

Figure 2 shows a photograph of the test rig with grillage specimen in place and top cover plate removed. Figure 3 shows "Crow's feet" which were added to the transverse tees after preliminary pressurization indicated that the grillage would tear out along the clamped sides. Also, a short bar, which holds down the flange of the transverse tees, may be seen. Figure 4 shows the cover plate in place and the grillage ready for test.

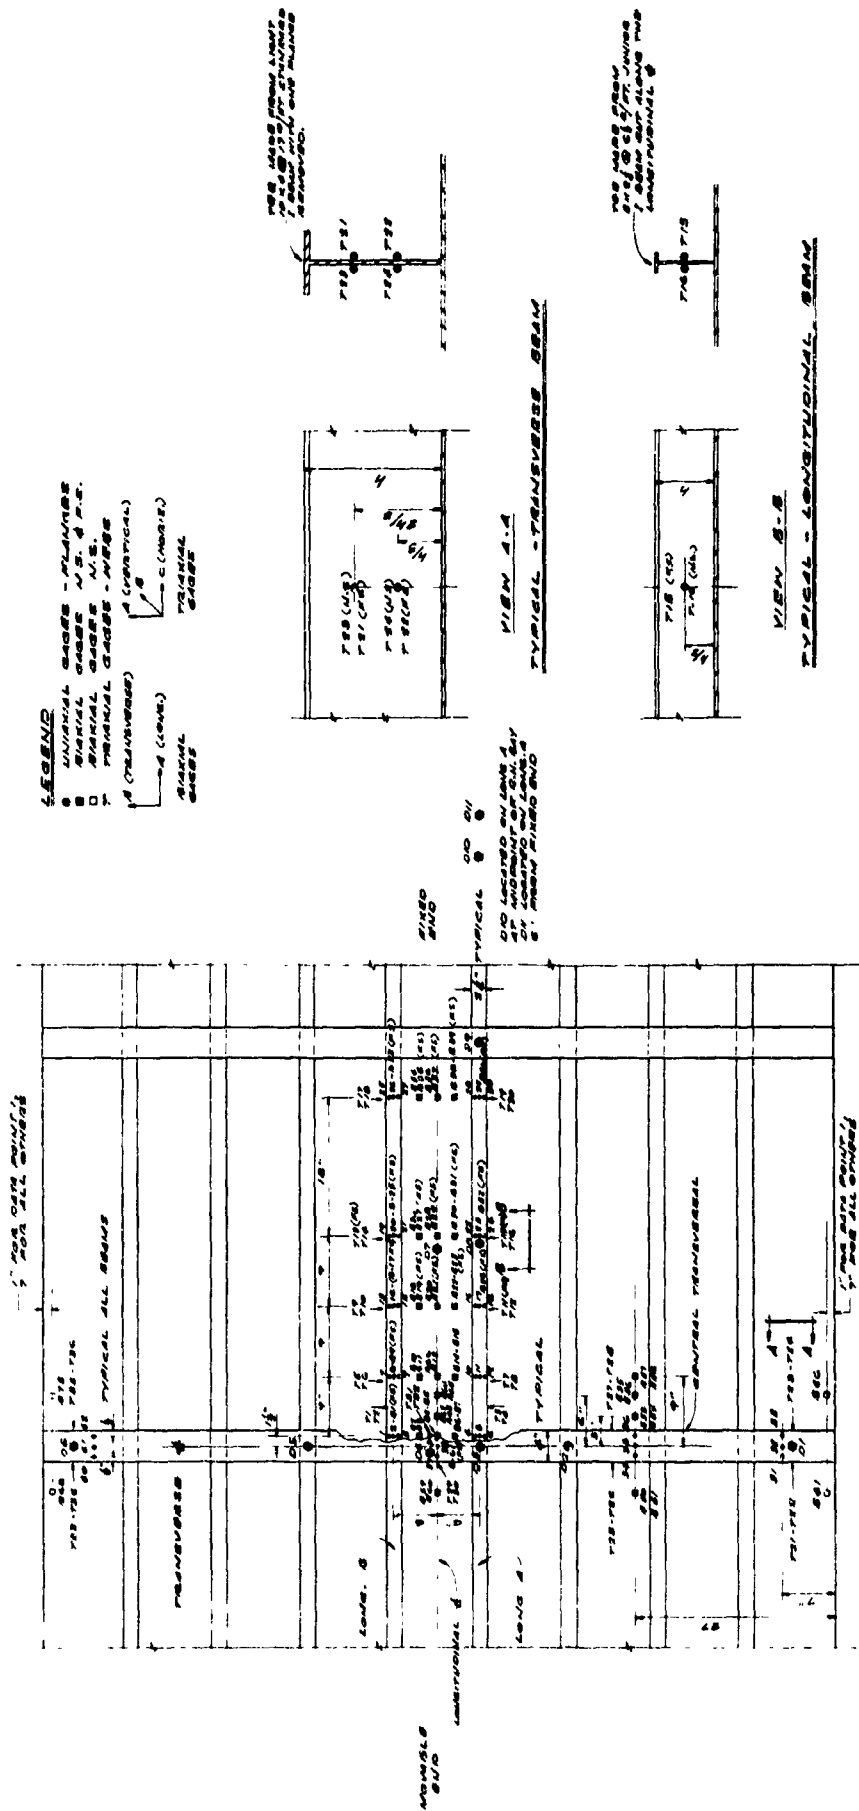
FIGURE 6. STRAIN GAGE AND DIAL GAGE LOCATIONS FOR TEST 1

Test 1(a), the only completely instrumented test, had a total of 302 strain gages, plus several Ames dial gages, located as shown in Figure 6. During test, strain and deflection readings* were taken for ten separate combinations of axial compressive stress and normal pressure which result from design curves currently in use at the Naval Ship Systems Command. These combinations are given in Table I where they are designated as Data Points. During the tests, each Data Point was obtained by first applying the axial load to the required value, then gradually increasing the normal pressure while holding the axial load constant. When the Data Point was reached, strain and deflection readings were taken and recorded. Also, in the case of Data Points 5, 6 and 7, intermediate readings were taken at values of $1/3$ and $2/3$ of the required normal pressure. As will be seen from Figure 4, deflection readings were obtained along one of the beams near the longitudinal centerline of the grillage and along the beam which forms the central transversal. The resultant readings are plotted in Figures 7(a) and (b).

All references in Figures 15 to 24 are, with regard to strain gage location and the designation of stiffeners, according to Figure 6. The axis "x" is in the longitudinal direction. i. e., parallel to stiffeners, and the axis "y" is at right angles to "x". Figures 15, 16 and 17 are plots of the ϵ_y strain at the top and bottom surfaces of the plating and Figures 18, 19 and 20 are plots of the ϵ_x strain at the same location. These strain readings are taken at a transverse section sufficiently far removed from the central transverse stiffener to avoid the local disturbance in stress flow produced by the transverse beam.

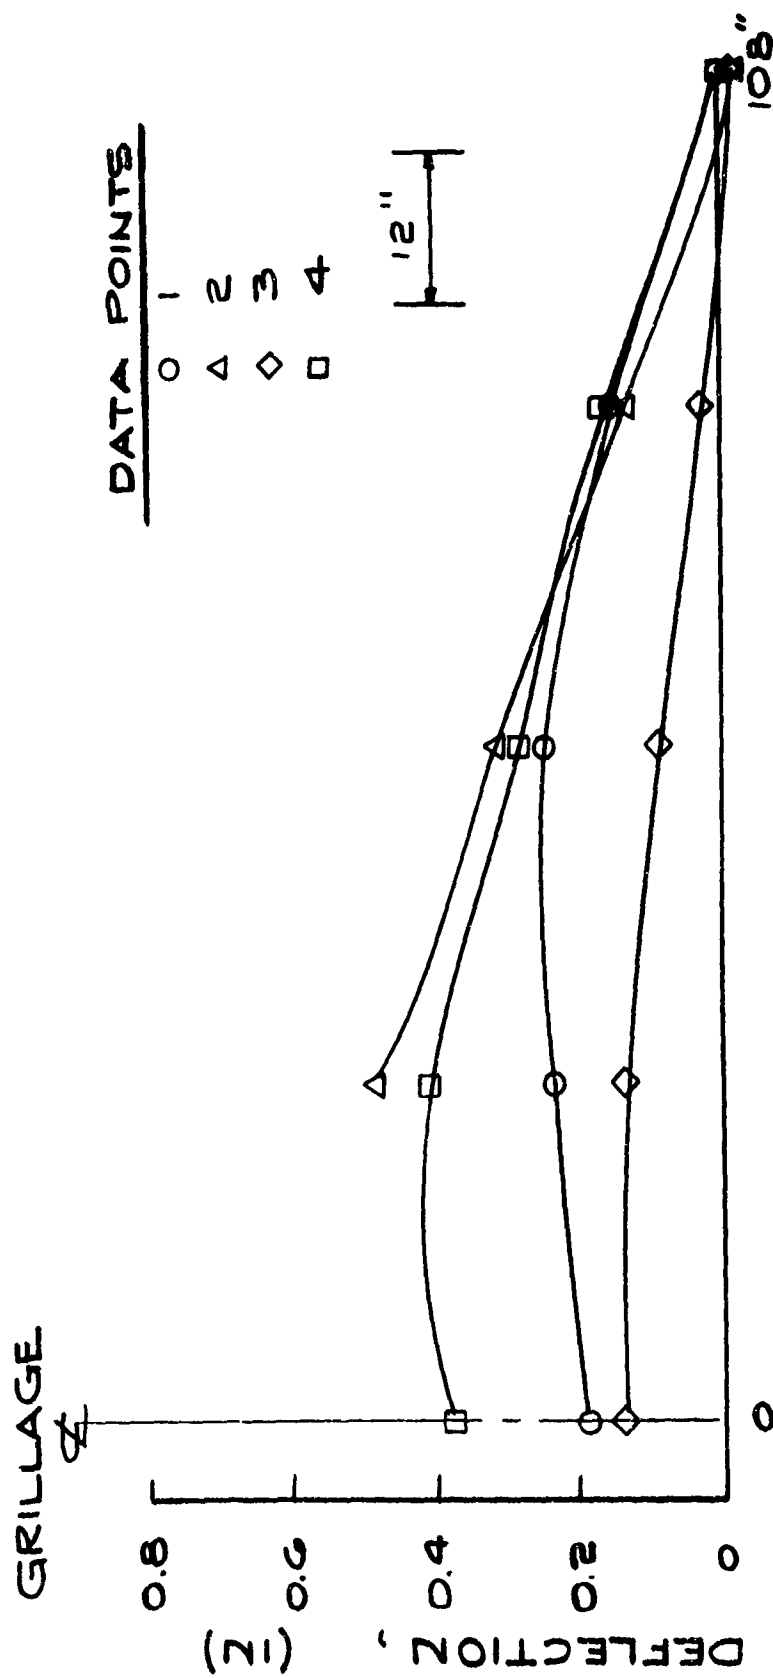
FIGURE 7(a). DEFLECTION OF THE GRILLAGE MEASURED ALONG LONGITUDINAL "B"

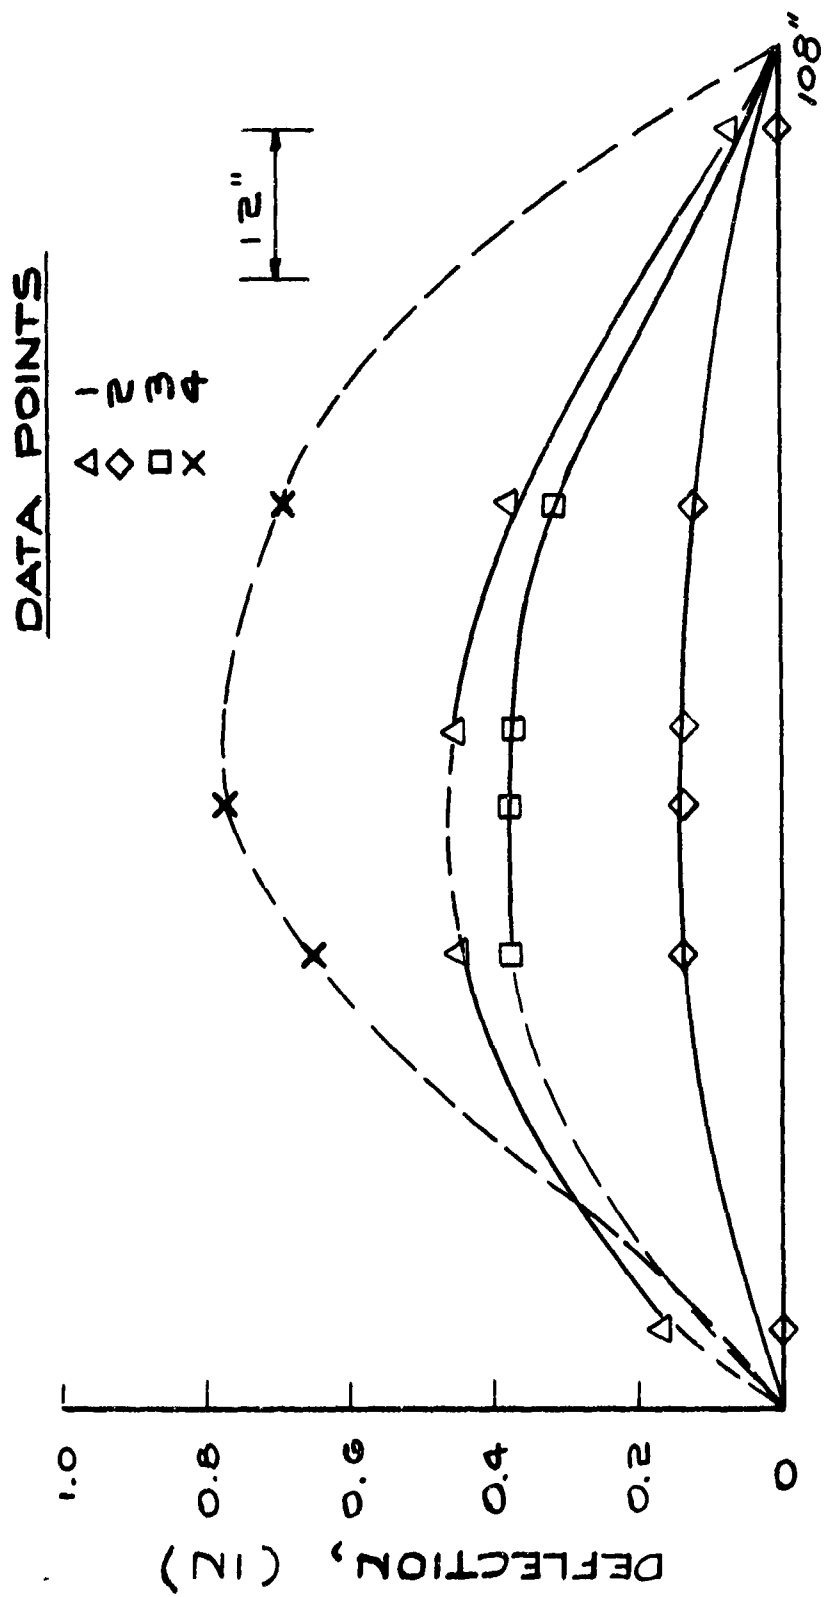
FIGURE 7(b). DEFLECTION OF THE GRILLAGE MEASURED ALONG THE CENTRAL TRANSVERSAL

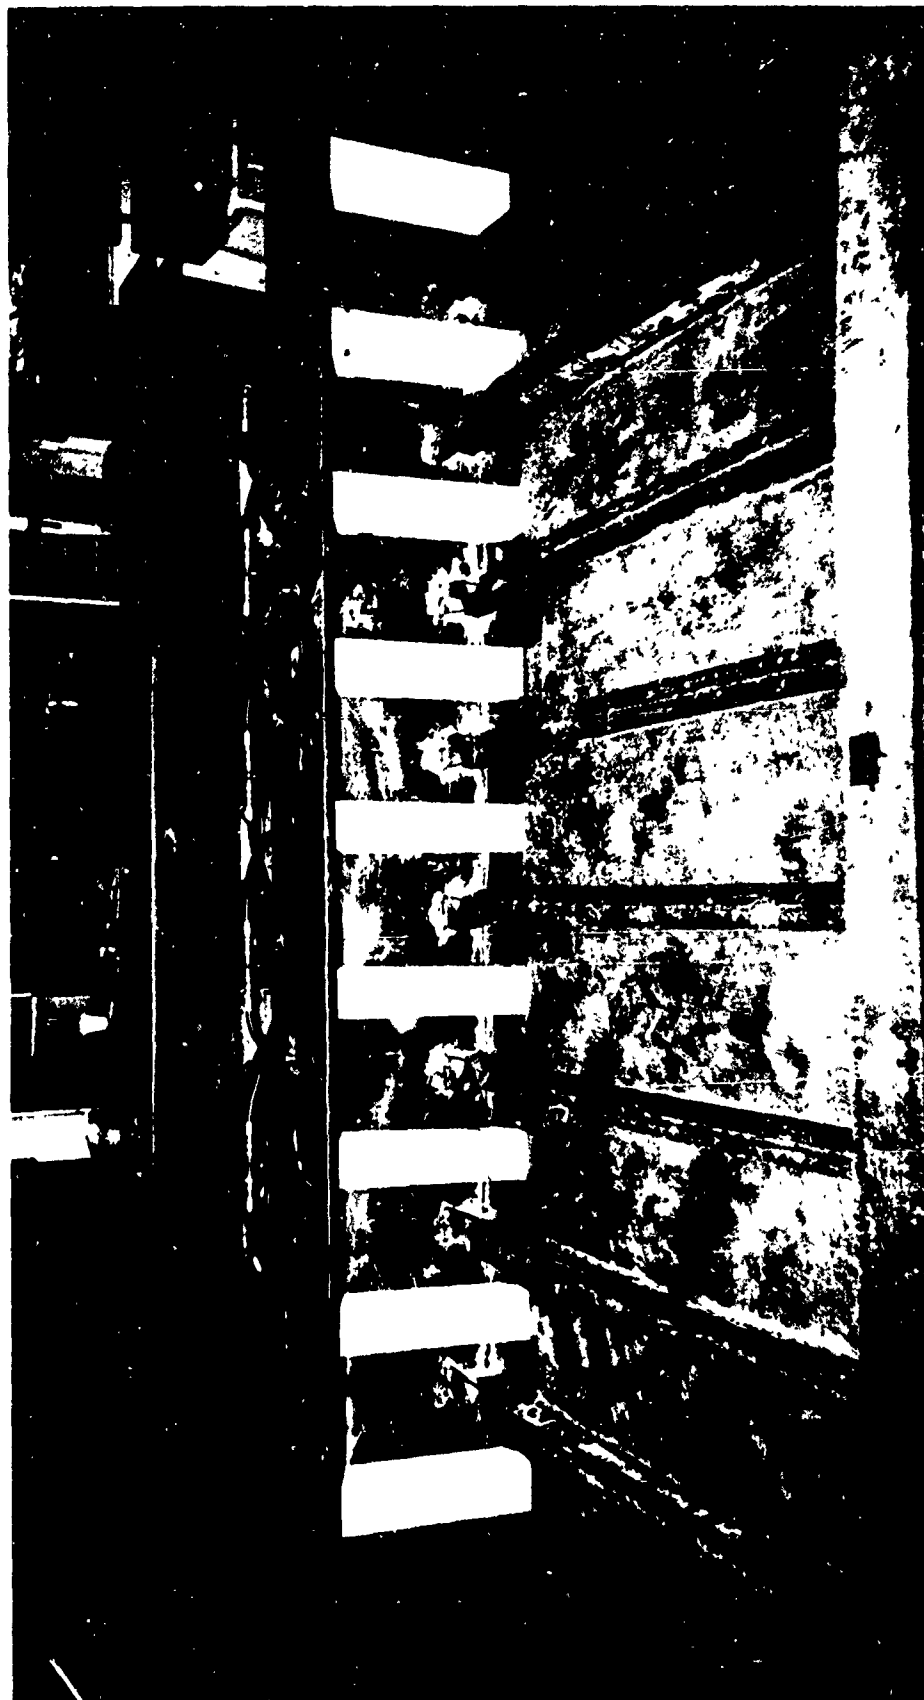
FIGURE 8. CRIPPLING OF THE GRILLAGE STIFFENERS AT THE
LOADING END, TEST 1(b)

An examination of the grillage after test showed "failure" resulted from localized buckling of the longitudinal stiffeners at the end where the axial pressure was applied. This may be seen in Figures 8 and 9, which are overall and close-up views, respectively. In contrast to the gross buckling of the "moveable" end, the "fixed" end of the grillage, showed only a slight waviness in the stiffener flanges. This may be seen in Figure 10. The stiffeners in the two intermediate panels were virtually unaffected except for a slight ripple in one of the stiffeners in the second panel from the loading end, see Figure 11.

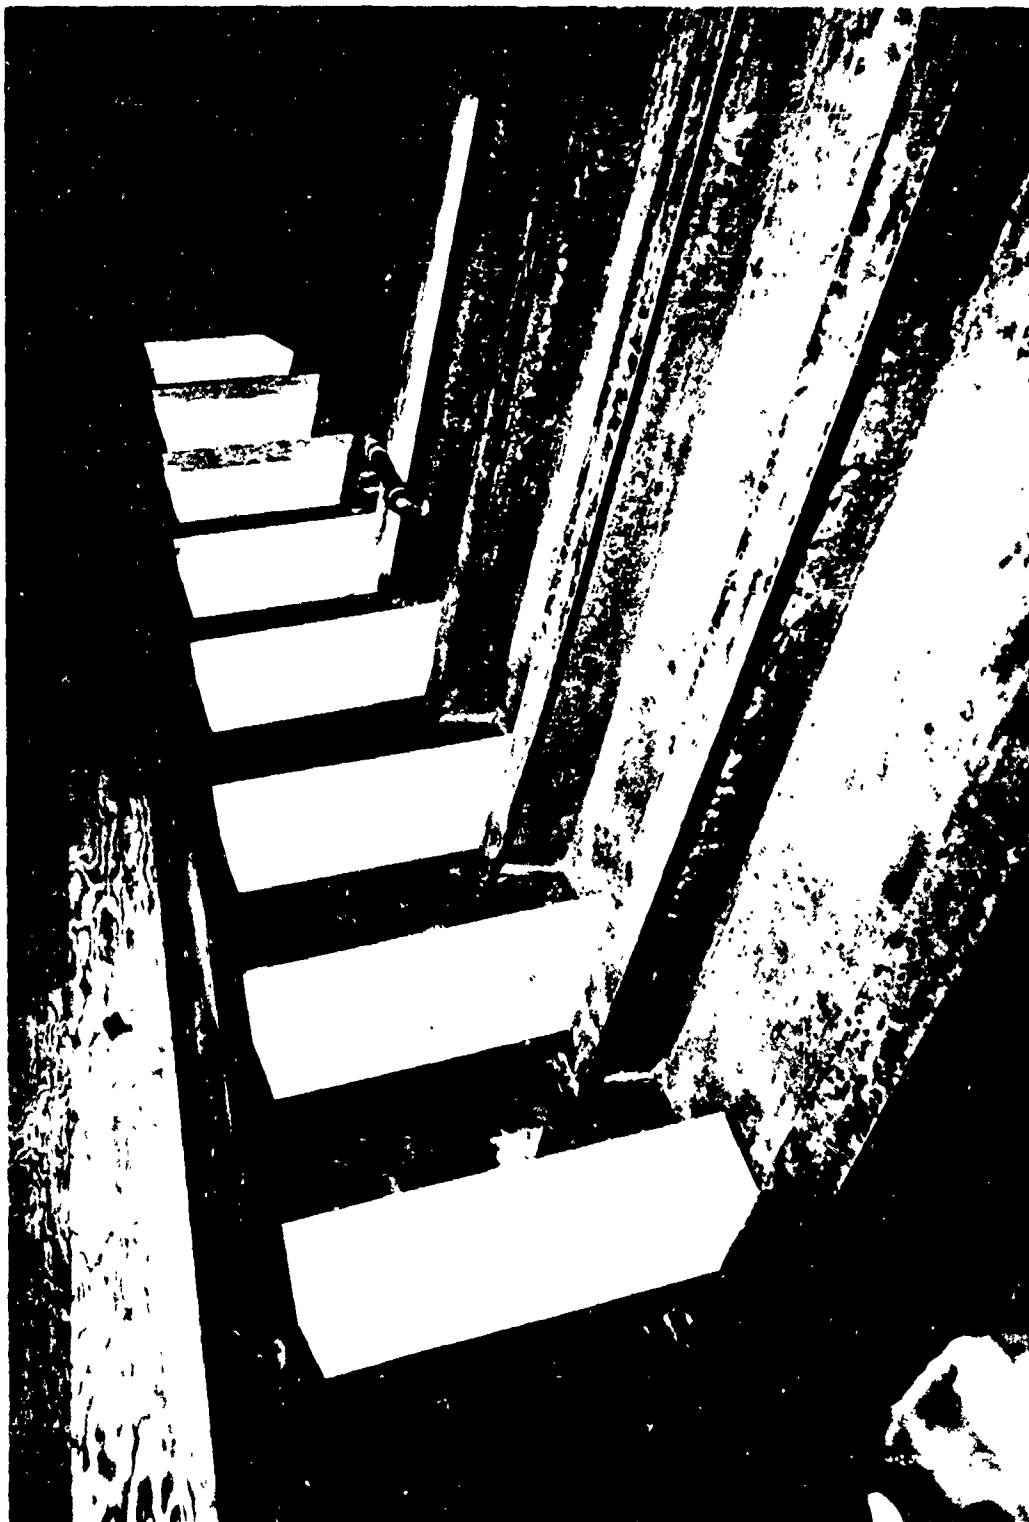
FIGURE 10. "FIXED END" OF GRILLAGE, TEST 1(b)

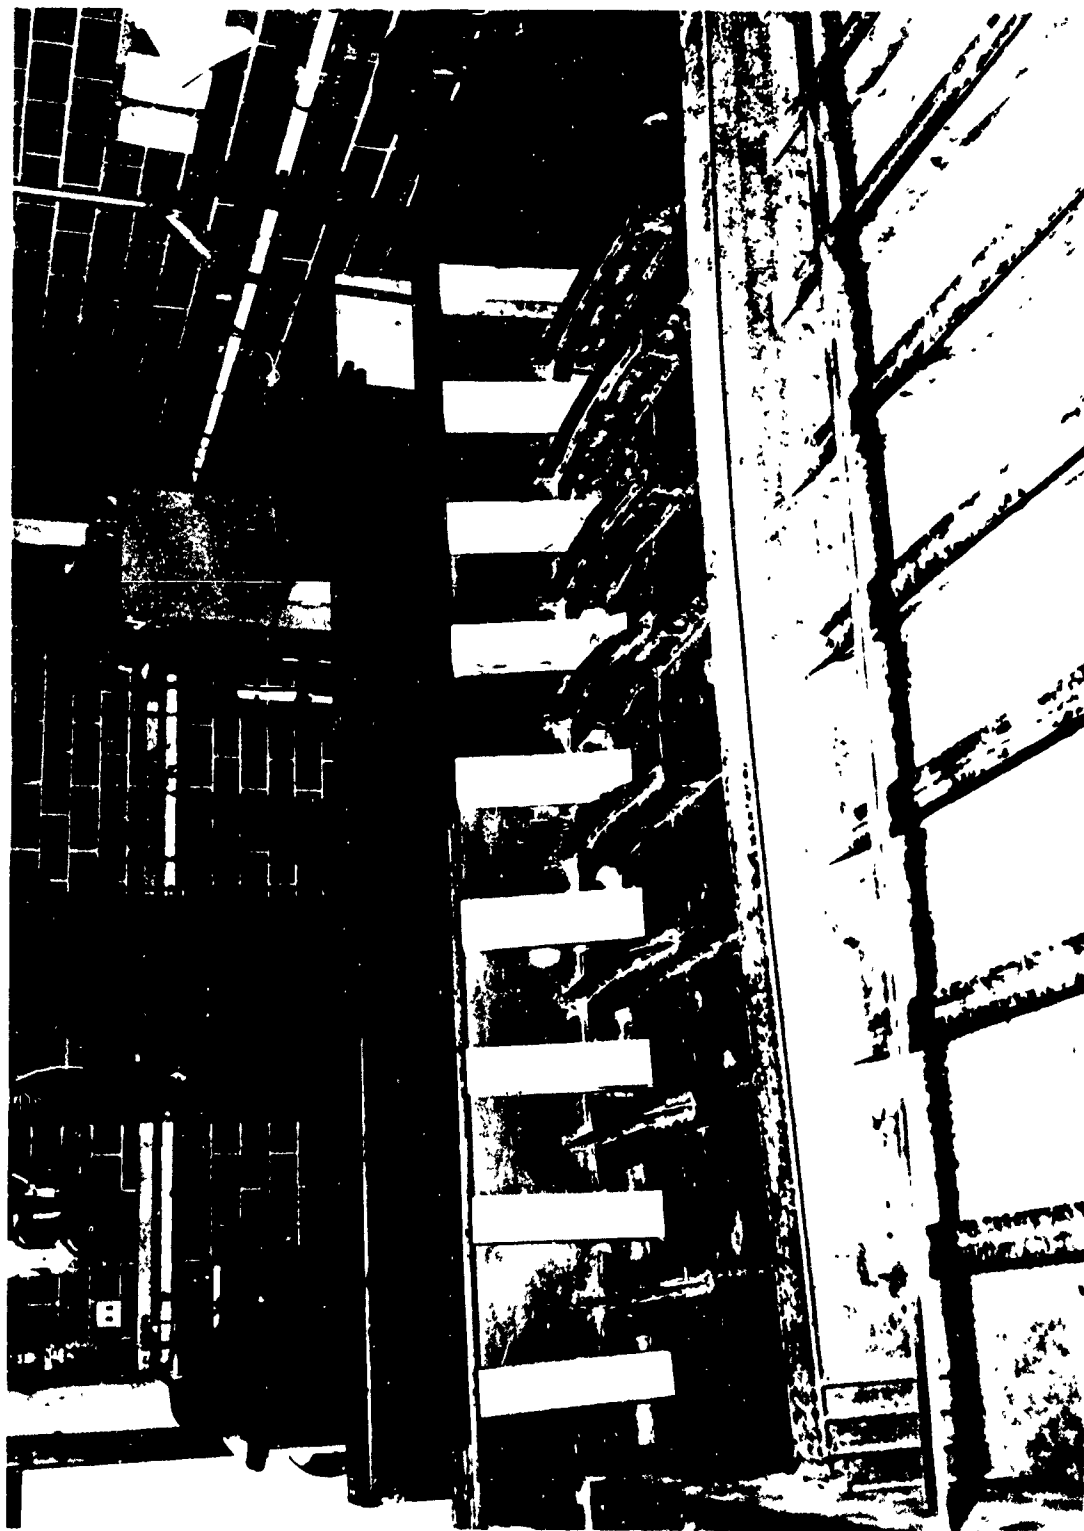
FIGURE 12. CRIPPLING AT THE LOADING END AFTER TEST 1(c)
(NOTE THE CONFIGURATION OF THE END STIFFENER)

To achieve this purpose, the buckled ends of the stiffeners and the crumpled grillage plating at the loading end were removed. A new section of plating was spliced into place and especially-fabricated tapered tees were welded to the plating. These tees were also welded to the cut-back longitudinals, thus providing a more gradual means of load transfer from moveable beam to the grillage specimen. This modification may be seen in Figure 12. At the fixed end of the grillage, vertically placed triangular sections were welded to the flanges and stabilized by an angle welded across the width of the grillage, see Figure 13.

Examination of the grillage after test showed essentially the same features as in Test 1(b), namely a crippling of the stiffeners at the loaded end. An overall collapse of the grillage did not occur. At least in part, this was because of insufficient torsional rigidity within the heavy I-beam against which the jack pressure is applied. This beam, which is shown in Figure 14, bent and twisted so that the load was no longer applied at the center of gravity of the deformed section.

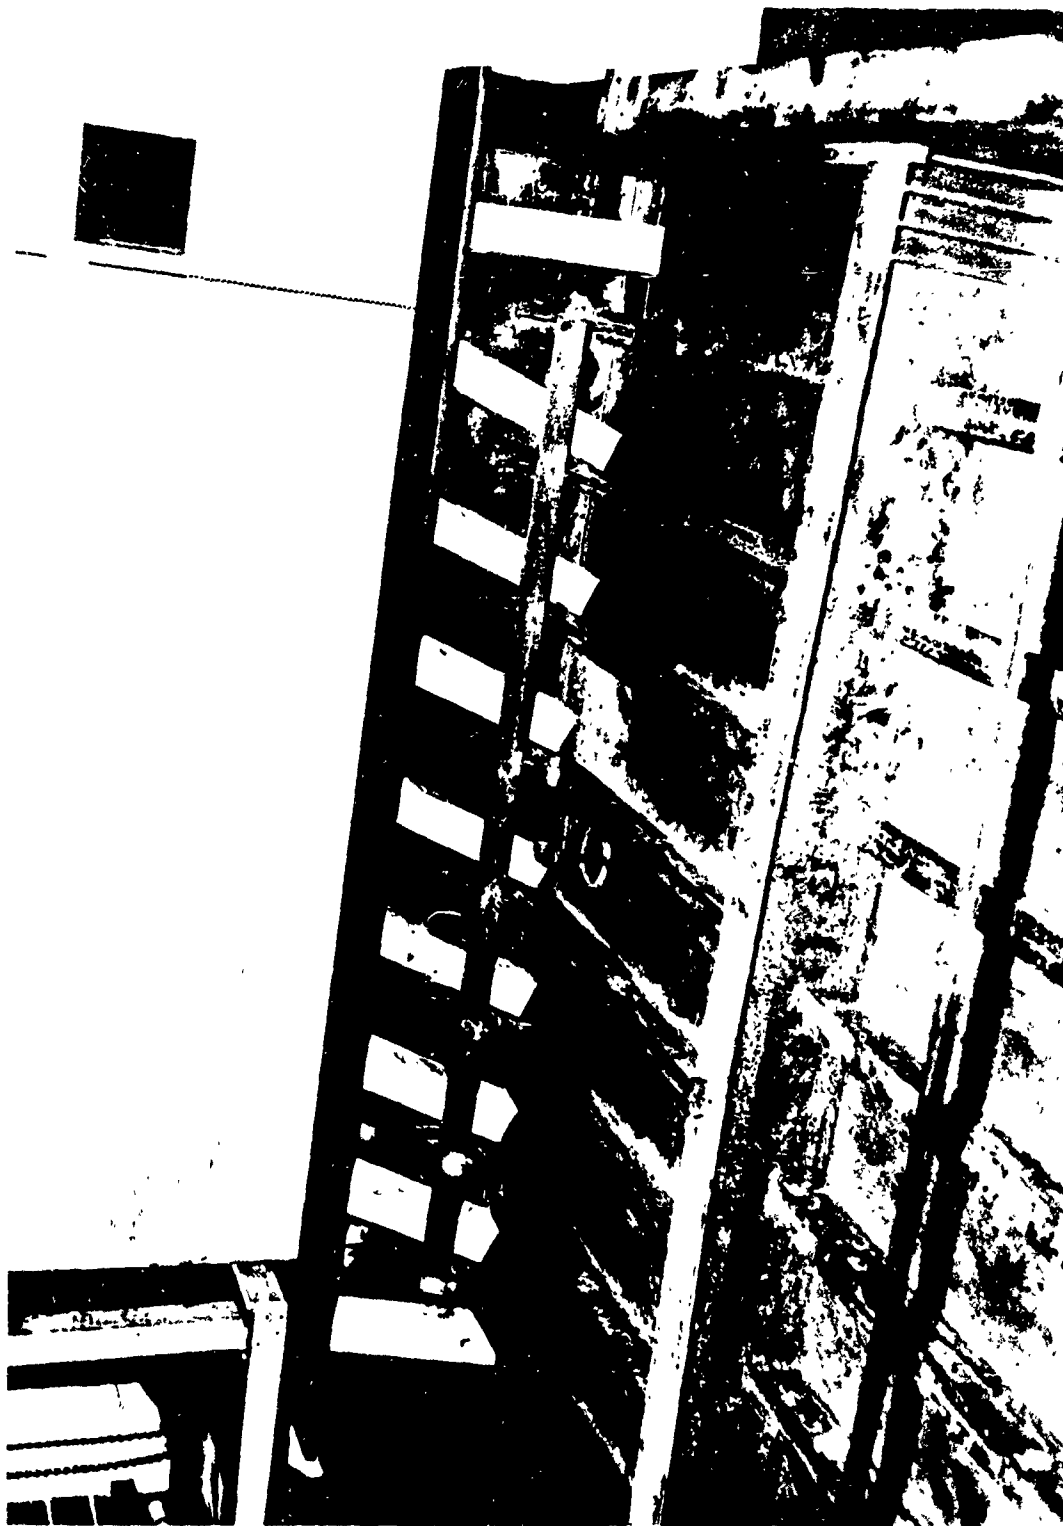
FIGURE 13. THE FIXED END, TEST 1(c)

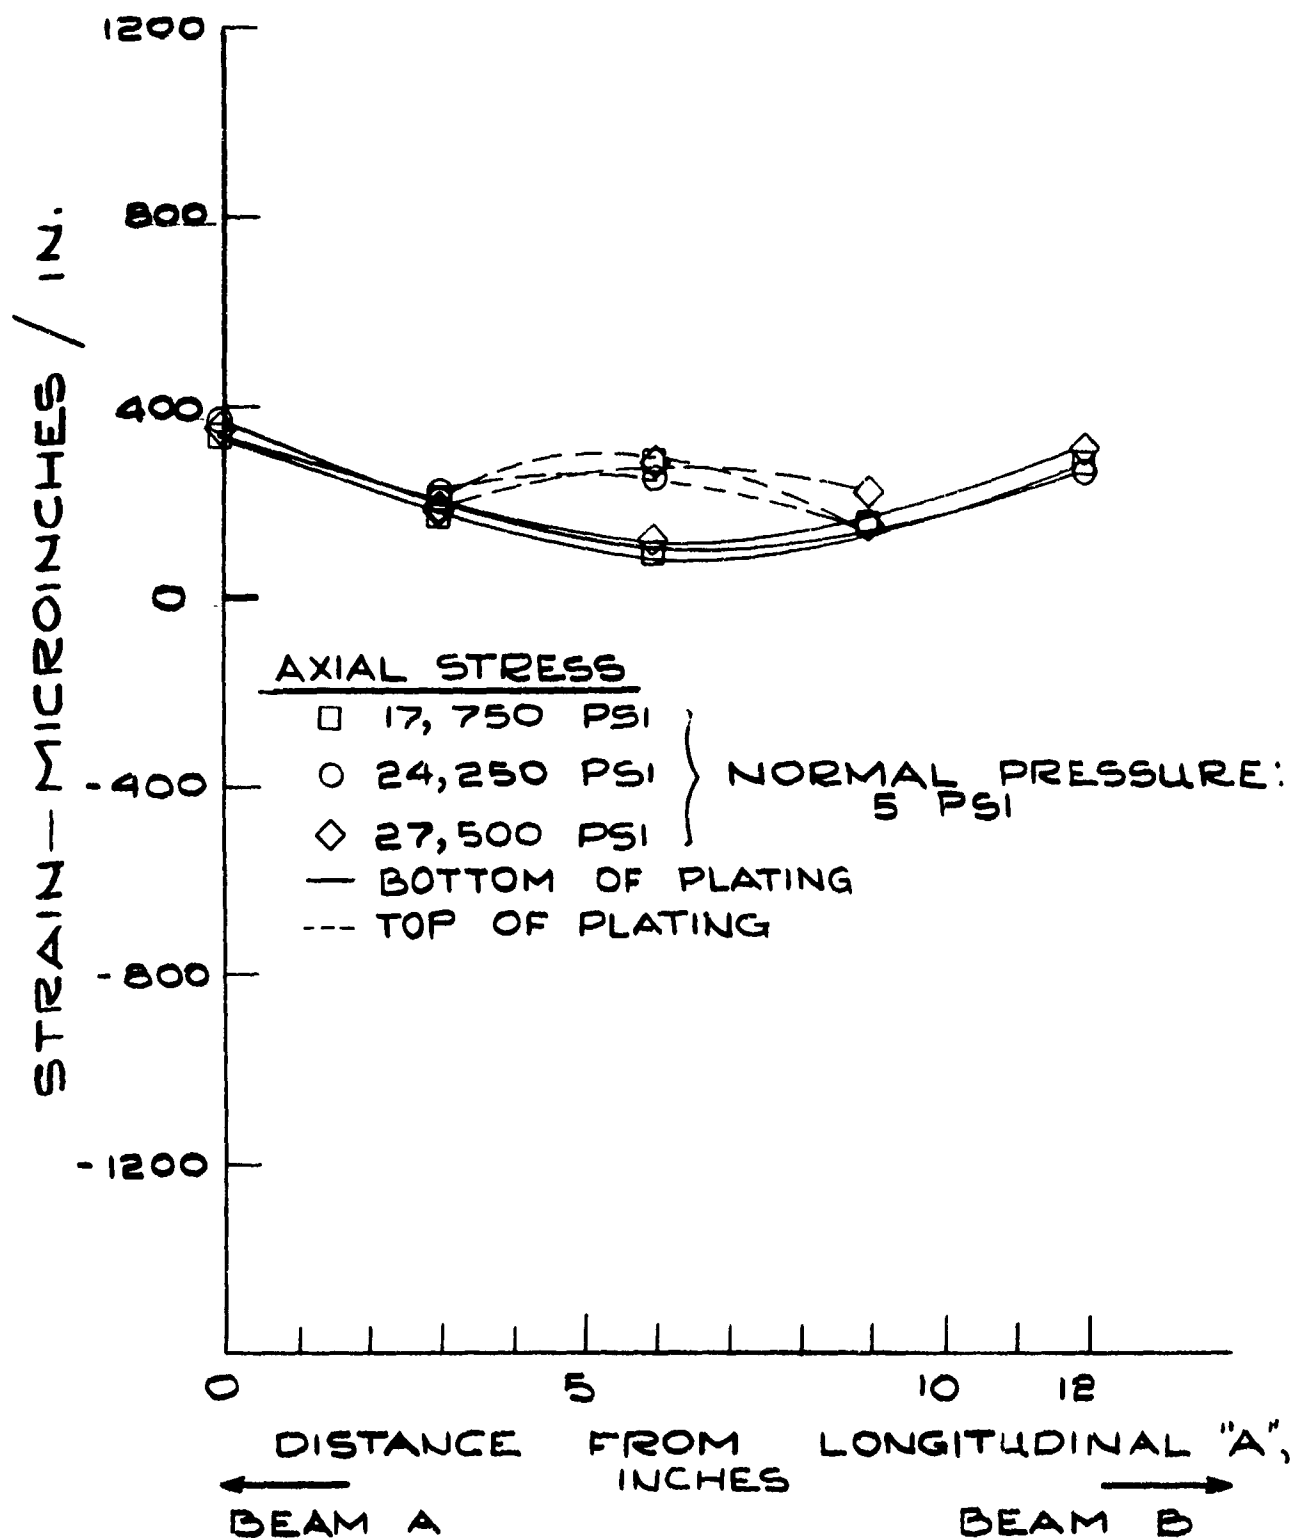
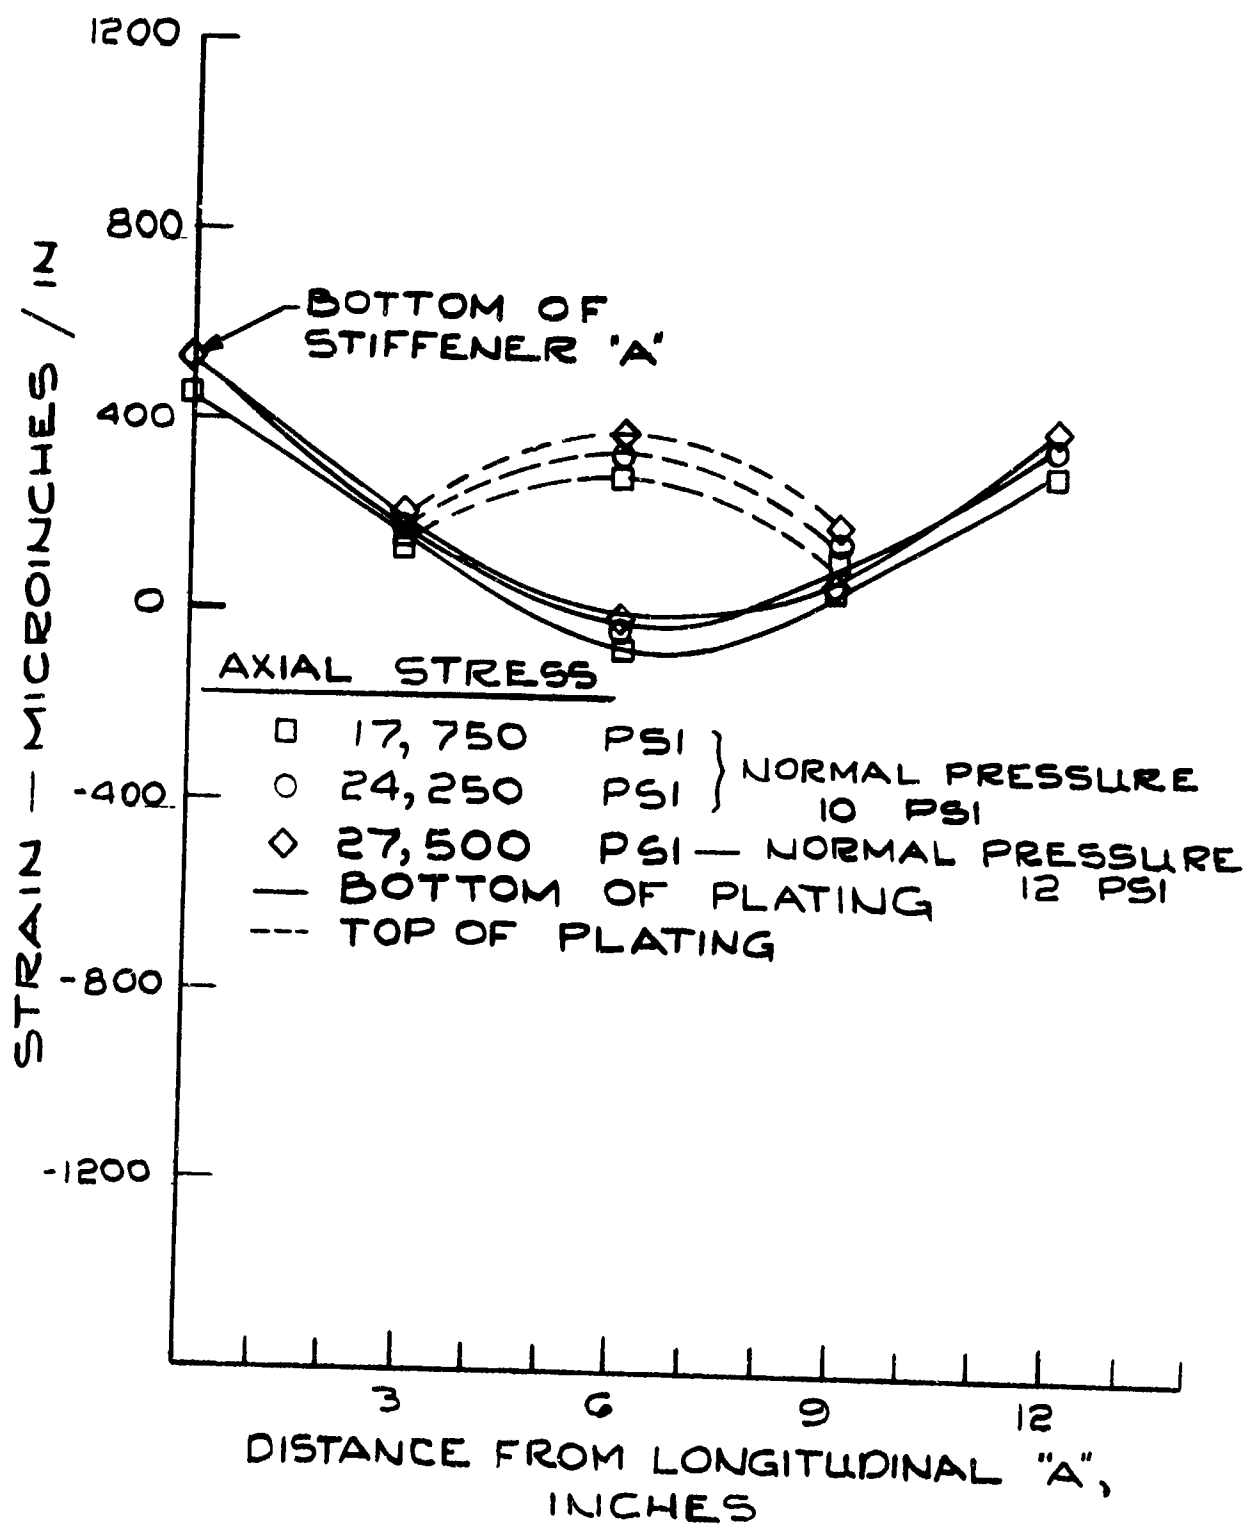
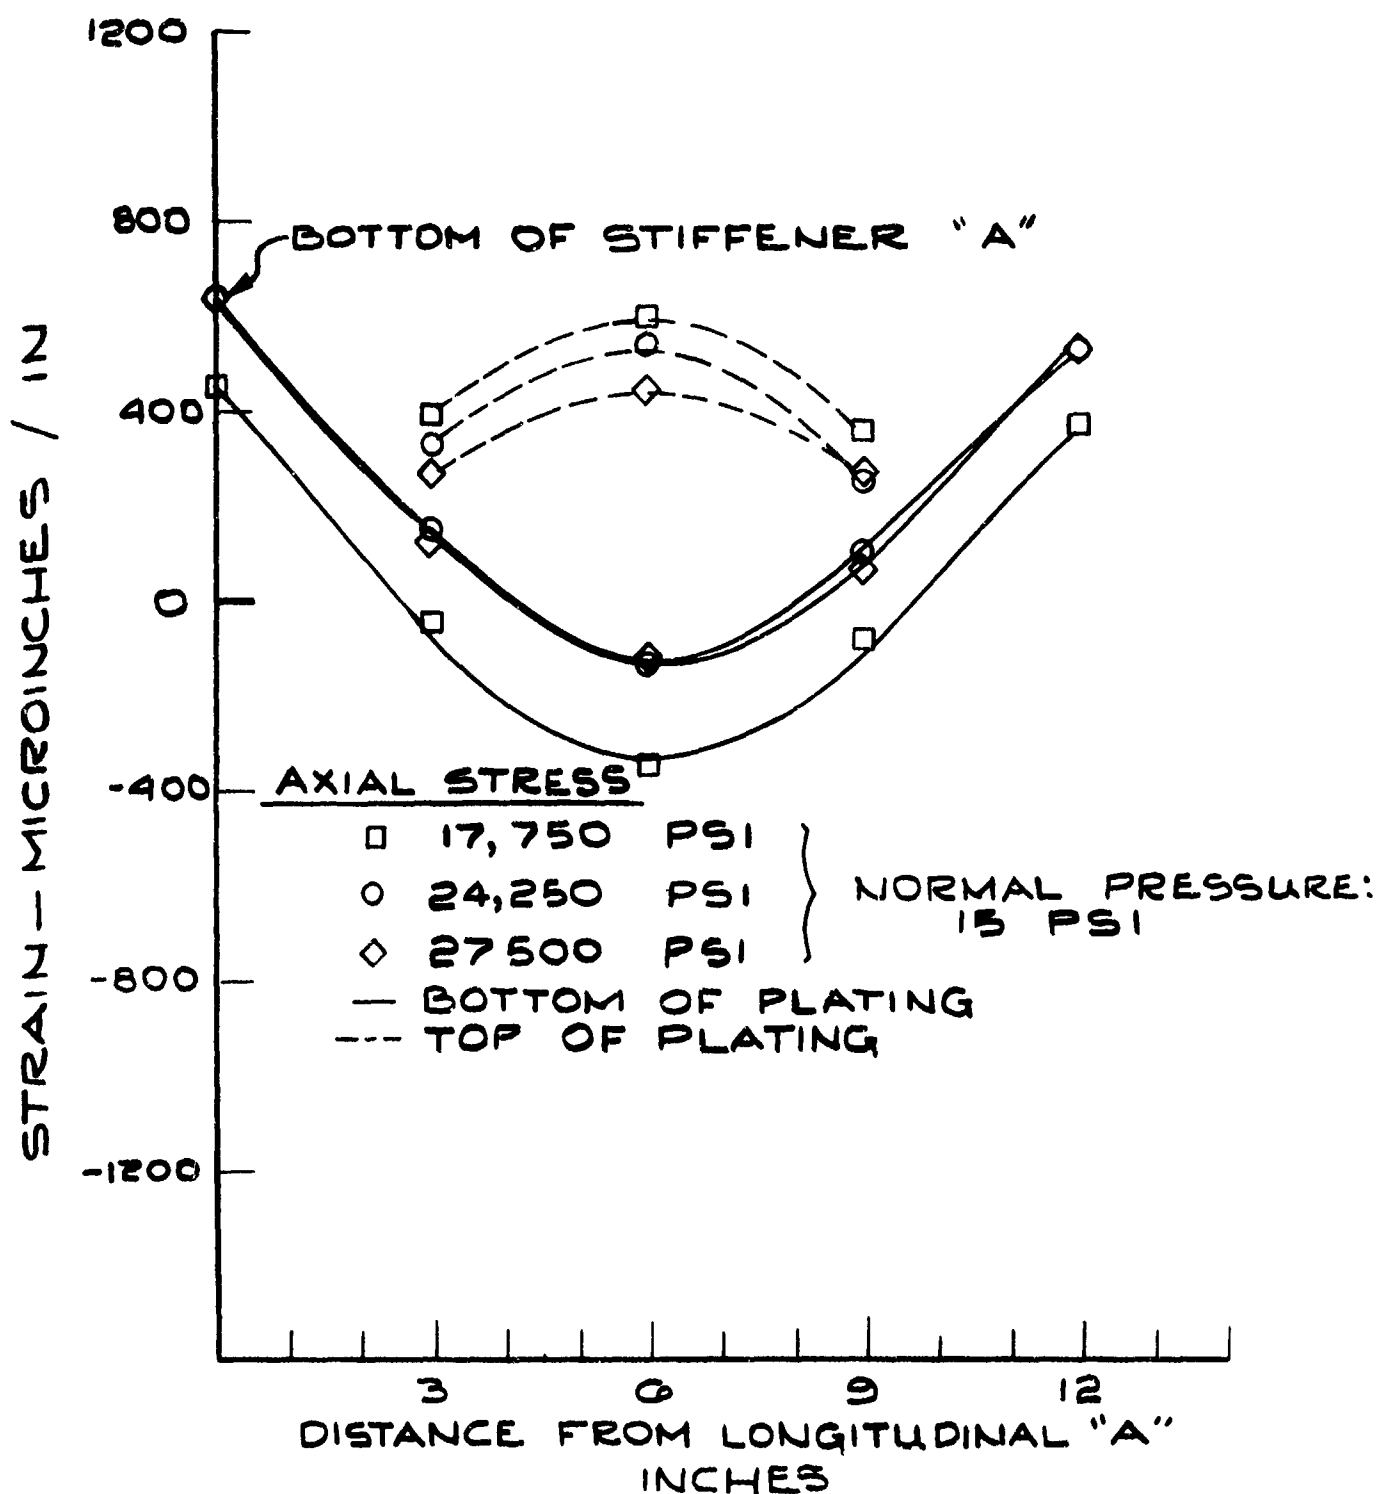
FIGURE 15. STRAIN, ϵ_y , IN THE PLATING 27" FROM THE CENTRAL TRANSVERSAL

FIGURE 16. STRAIN, ϵ_y , IN THE PLATING 27" FROM THE CENTRAL TRANSVERSAL

FIGURE 17. STRAIN, ϵ_y , IN THE PLATING 27" FROM THE CENTRAL TRANSVERSAL

The foregoing statement is reinforced by examination of Figures 15, 16 and 17 which show plots of the ϵ_y strains in the plating. The strains are always greater on the top surface than on the bottom and, when the pressure is low (5 psi), both sets of strains are positive; in contrast, for the higher pressures, the strains in the bottom become negative and the difference between the strains at the top and the bottom surfaces become greater with increasing normal pressure. These results can be shown to mean that, for the higher normal pressures, the plating bends to a cylindrical surface and at the lower pressures, there is a "membrane tension" in the plating in the transverse direction. This membrane action is reduced at the higher pressures because of the Poisson effect produced by the axial compressive load.

Figures 15, 16 and 17 show that ϵ_y increases with normal pressure. This is to be expected because the plate has a strong curvature at the longitudinal stiffeners and the symmetry of the structure prevents rotation of the longitudinals; the panel, therefore, acts like a "fixed ended" plate. ϵ_x , on the other hand, is practically unaffected by the normal pressure and as the preceding equation shows, as normal pressure is increased, σ_x in the plating is reduced. Since the total axial load does not change with increasing normal pressure, this can only mean that part of the axial load is transferred to the boundaries. This is very similar to the "effective width" phenomenon, long recognized in the post buckling behavior of plating. Therein, it has been found that the nature of the boundaries always plays an important part in the mechanisms of failure and must, therefore, be taken into account in an ensuing analysis.

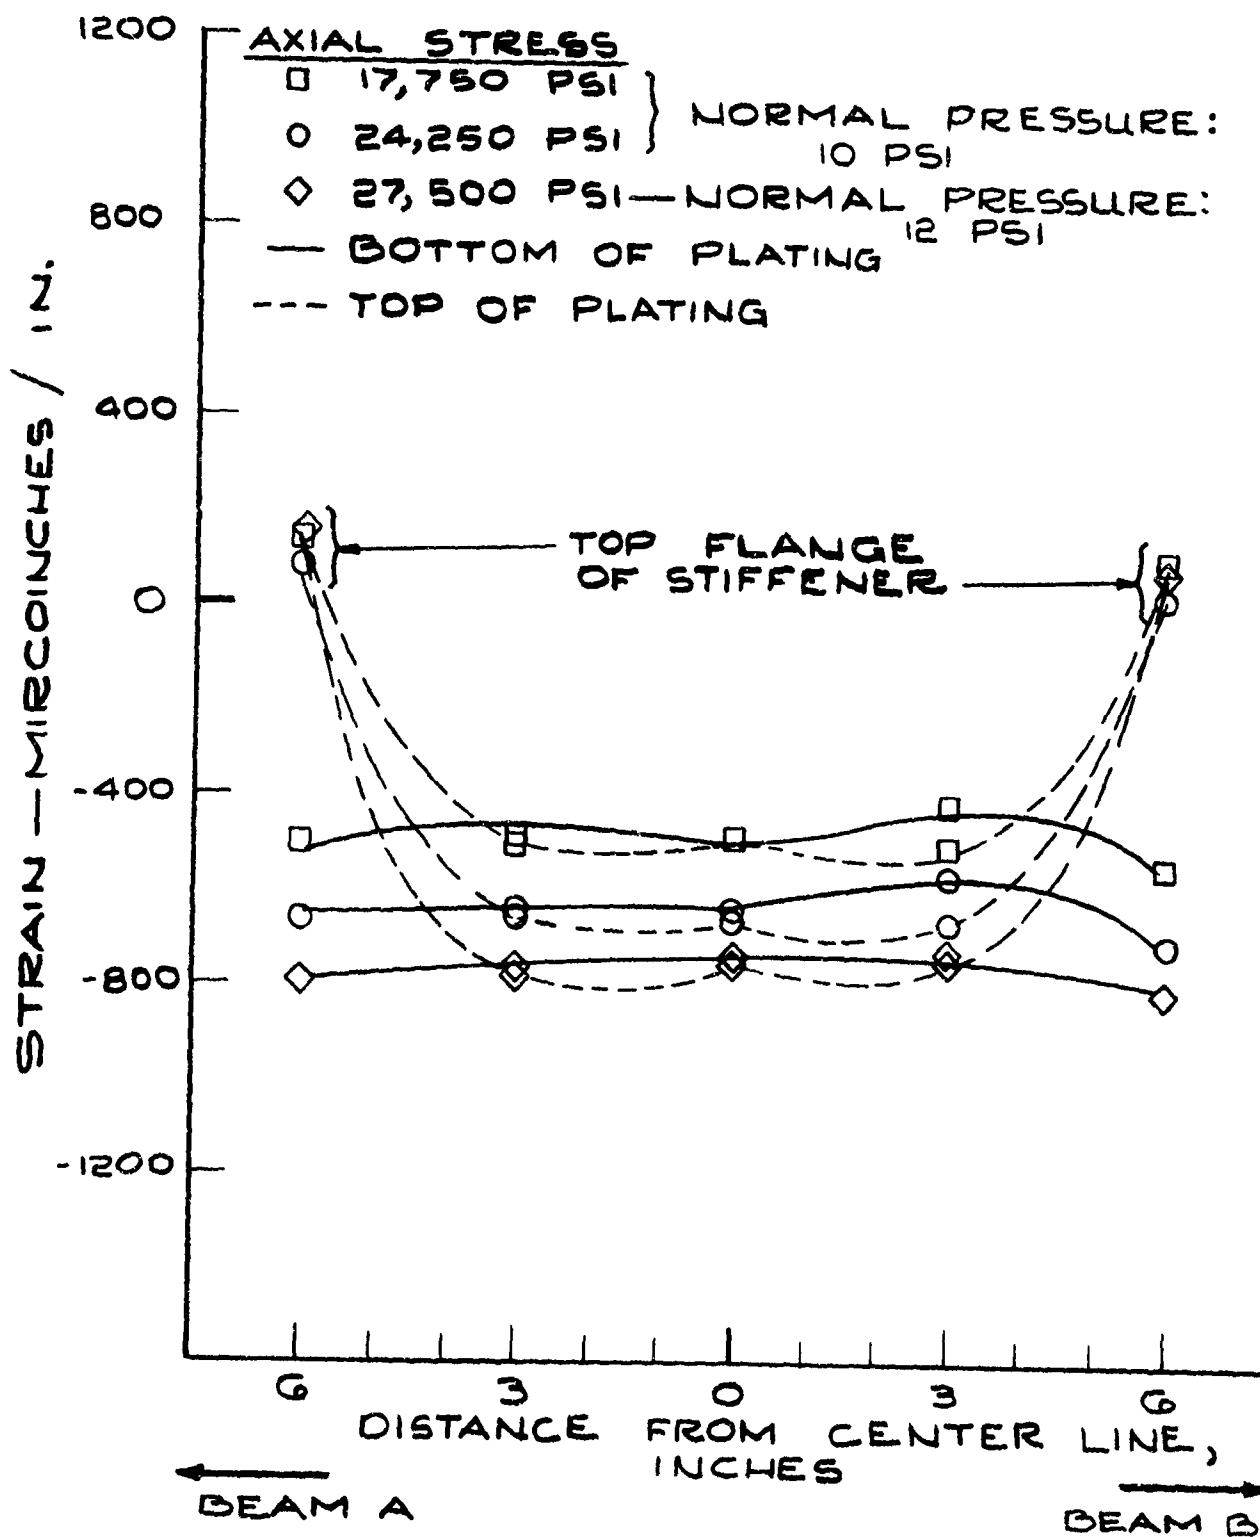
FIGURE 18. LONGITUDINAL STRAIN, ϵ_x , IN THE PLATING 27" FROM THE CENTRAL TRANSVERSAL

FIGURE 19. LONGITUDINAL STRAIN, ϵ_x , IN THE PLATING 27" FROM THE CENTRAL TRANSVERSAL

FIGURE 20. LONGITUDINAL STRAIN, ϵ_x , IN THE PLATING 27" FROM THE CENTRAL TRANSVERSAL

It will be seen from Figures 18, 19 and 20 that the longitudinal strain in the plating, ϵ_x , is essentially uniformly distributed at all the combinations of axial force and normal pressure. The greatest deviations from uniformity are at the highest normal pressure of 15 psi. Furthermore, small and the magnitude does not change appreciably with normal pressure. It does change, however, with a change in axial pressure. This shows that: (a) the axial load is carried nearly uniformly by the plating and (b) the bending stresses in the longitudinal direction are small. These conclusions

are in conformity with usual design assumptions, i. e. , that because of the panel aspect ratio, the plate undergoes "cylindrical bending. "

Consider Equation (5) which gives the membrane stress σ_y' . At 5 psi, Figure 14 shows that both ϵ_y^T and ϵ_y^B are positive; then from Figure 18, ϵ_x^T and ϵ_x^B are both negative. Thus, the membrane stress has a positive value for small pressures. As the normal pressure increases, however, ϵ_y^B becomes negative (see Figures 16 and 17); therefore, although $\epsilon_y^T + \epsilon_y^B$ still remain positive, the effect of the negative value of $\mu(\epsilon_x^T + \epsilon_x^B)$ reduces the value of σ_y' . Also, this reduction increases for greater values of the axial compressive stress. As an example, at 5 psi normal pressure and 17,750 psi axial stress:
